EXISTING CONDITIONS

2.0 INTRODUCTION

2.2 MCDOUGLE ELEMENTARY OVERVIEW

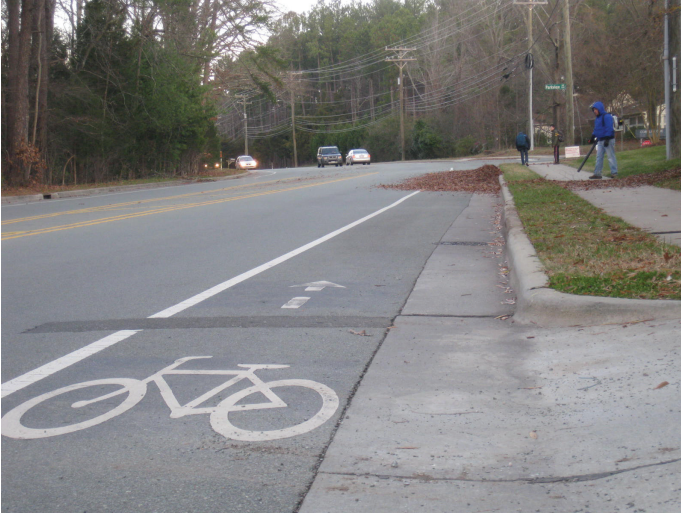
- Existing pedestrian facilities require regular maintenance. On-site observations took note of general maintenance issues along bicycle lanes as well as the pedestrian path connecting Quail Roost Drive to the McDougale campus. Bicycle lanes require regular sweeping to avoid possible injuries. Bicycle lanes along the adjacent roadways were littered with hazardous debris to cyclists. The path connecting Quail Roost to McDougale Elementary was in need of repair.

Private maintenance workers blow leaves into bicycle lane on Hillsborough Road.

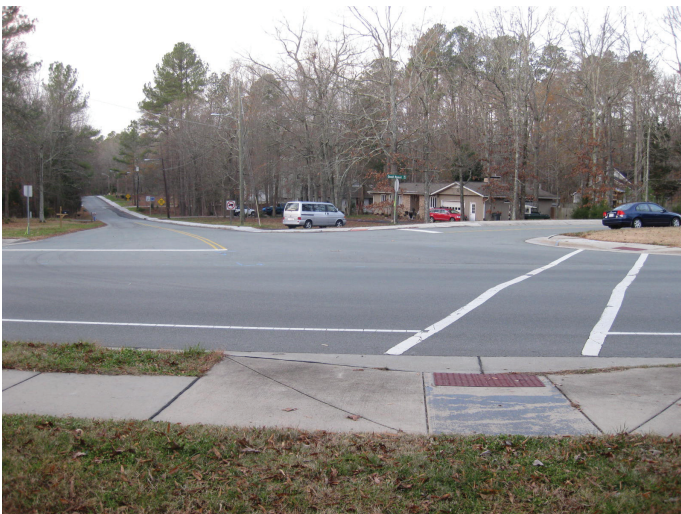
Other infrastructure features of concern in this vicinity included the use of standard pavement markings for the Hillsborough Road crosswalk rather than high visibility pavement marking alternatives. The marked crosswalk over Hillsborough Road is inadequate because it is not highly-visible. Additionally, the cross-

Intersection of Hillsborough/James/Quail Roost.

walk traversing James Street west of Hillsborough Road is very wide and has exceptionally wide curb radii due to the skew of the intersection. Again, both of these geometric features contribute to hazardous conditions for pedestrians and contribute to roadway inefficiency.

There is a marked sight distance hazard at the intersection of Hillsborough Road and James Street due to a curve northwest of the intersection. SRTS team members counted significant pedestrian traffic at this intersection, attributed to a path used as a short cut by students on Quail Roost Drive to the school grounds. Despite having a crossing guard in the past, there is not one currently.

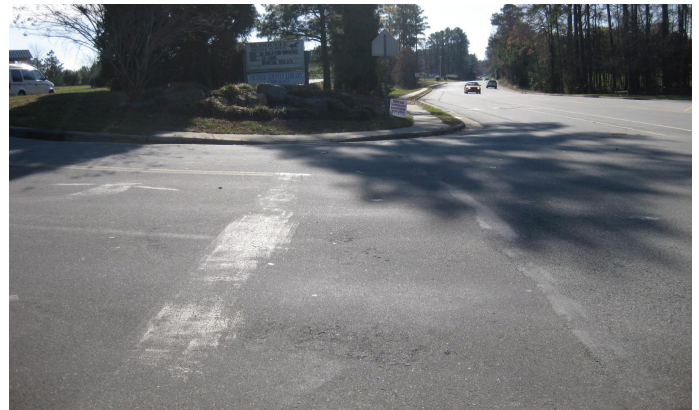
A police officer directs the ingress and egress of vehicular traffic at the main entrance. No students were observed walking across Old Fayetteville Road. With left and right turning lanes, it would be difficult to make significant crossing improvement under SRTS project budgets. However, there are alternatives for consideration.

Old Fayetteville Road and main school entrance.

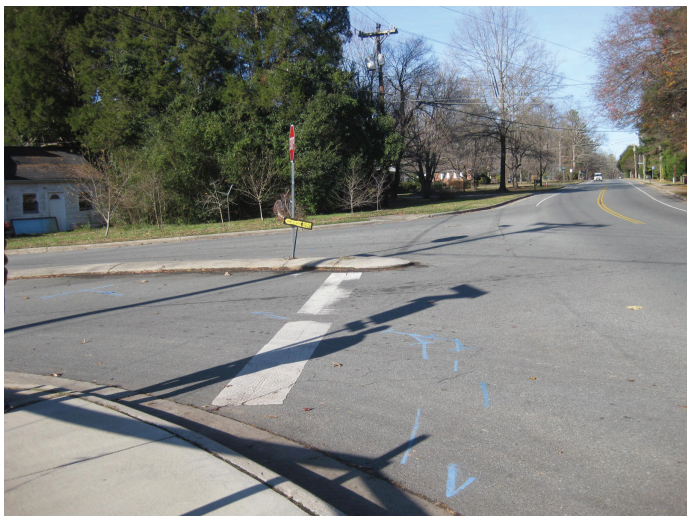
extensions and/or median refuge. It does not appear feasible to add marked crosswalk across Greensboro because of traffic and turning traffic, unless a stop-light is installed.

Hillsborough Road at Greensboro Street.

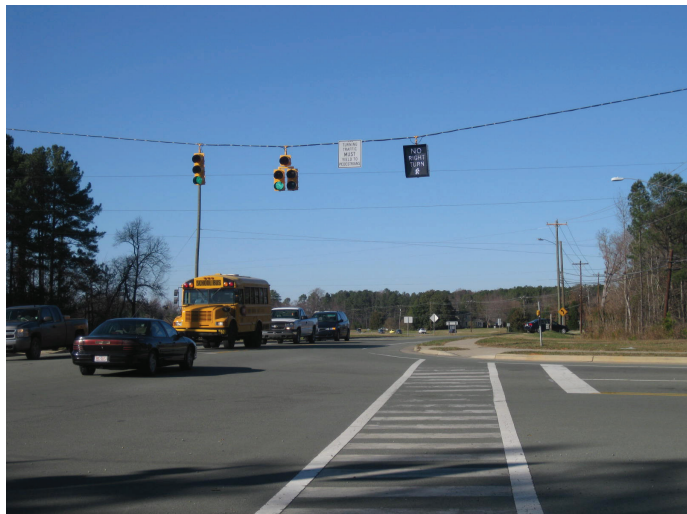
The traffic observed at this location appeared to be traveling at or above the posted speed limit of 45 mph. This may be due to the rural roadway environment preceding the intersection. This signalized intersection is equipped with a marked crosswalk on Hillsborough Road along with push button, count-down pedestrian signal heads. Also, with the pedestrian activation, a “No Turn on Red” light is engaged to make it safer.

Hillsborough Road at Old Fayetteville Road.

The crossing distance is wide due to the skew of the intersection and may even present a site distance obstruction for drivers approaching the intersection on Hillsborough Road. The Hillsborough Road alignment creates an acute left bend as it intersects Old Fayetteville Road. This is the roadway designers attempt to mitigate the intersection skew. However, drivers traveling northbound from the rural setting were observed approaching at high speeds and the bend in the alignment may actually impede the driver's sight distance and create an inability to see pedestrians mid-crosswalk.

Also, the southeast quadrant of the intersection is lacking sidewalk. The majority of pedestrians observed by SRTS team members were walking on the east side of Hillsborough Road to the crossing guard rather than crossing Hillsborough road to the main school entrance.

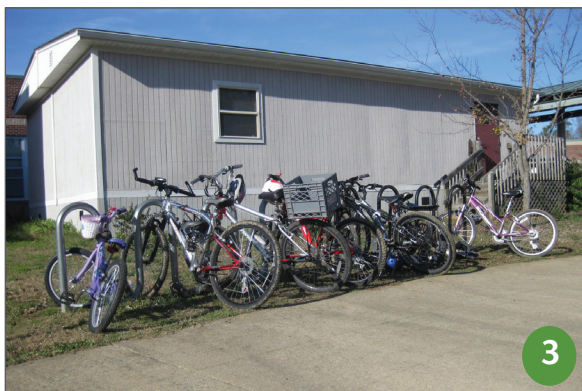
One of the bicycle racks on the east side of campus. This bicycle rack is full so additional bicycle racks may be needed.

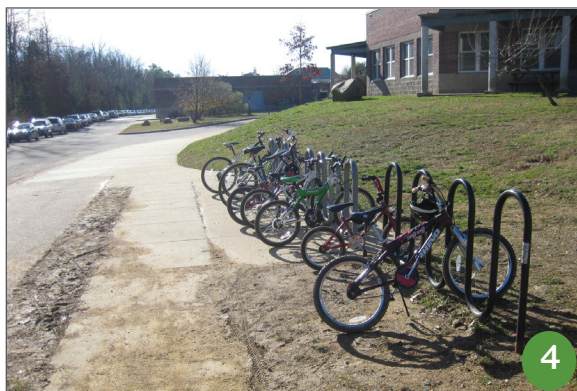
One of the bicycle racks on the east side of campus. This sidewalk accumulates muddy runoff from the slope.

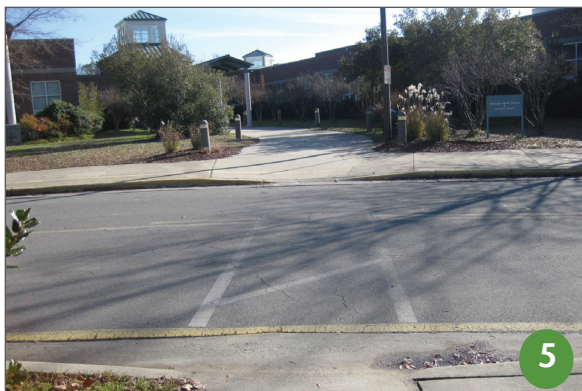
Faded marked crosswalk in the car drop-off loop in front of McDougle Elementary.

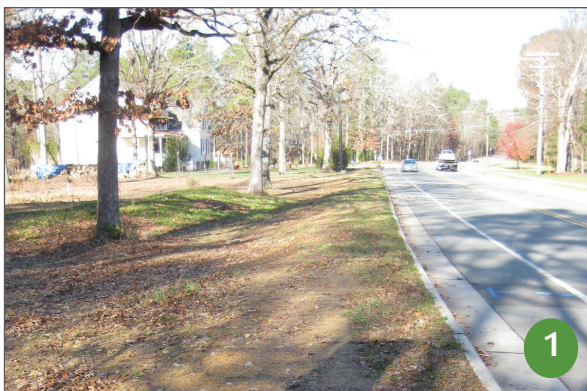
Key Sidewalk Gaps		
Roadway	Orientation	Gap Description
Hillsborough Rd.	West side	From Old Fayetteville Rd. to Greensboro St.
Old Fayetteville Rd.	East side	From McDougale Elementary to NC 54
Horne Hollow Path	Southern leg	From Existing trail (Autumn Dr.) to Hillsborough Rd.
NC 54/Main St.	North side	From High St. to Old Fayetteville Rd.

A gap in the sidewalk system along the west side of Hillsborough Road.

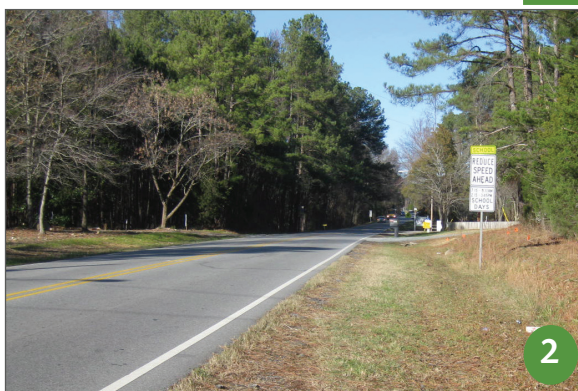
Another gap in the sidewalk system, here along Old Fayetteville Road, just south of campus.

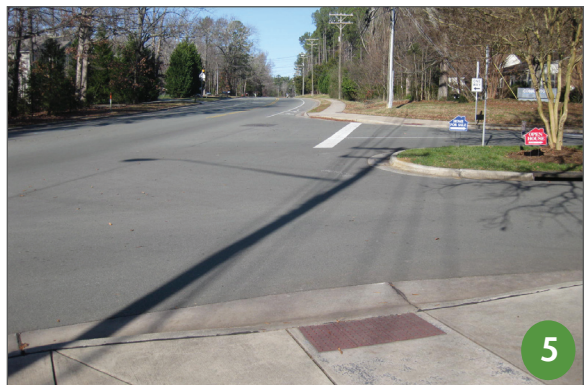
Sidewalk on the east side of Hillsborough Road does not feature marked crosswalks at crossings (Above: Parkview Avenue.)

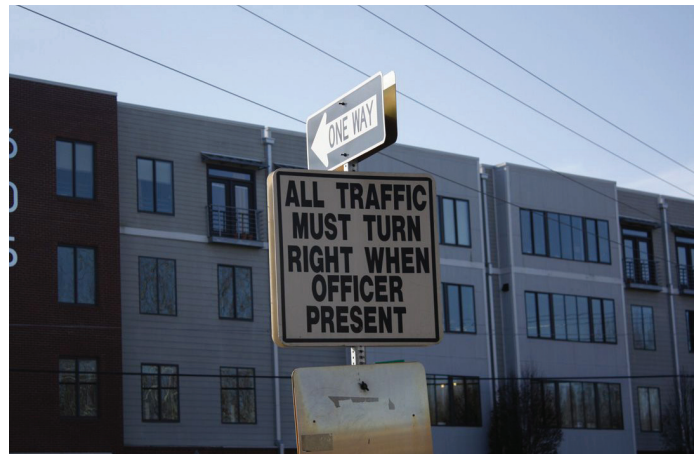
- The intersection of Shelton Street and Hillsborough Road seemed to be a cause of frustration for drivers exiting the school under the time-of-day directional constraint of “right out only.” Drivers often disobeyed the signage and signalization of the crossing guard by turning left. It was only with the introduction of the law enforcement officer on site during the observation period that complete compliance was implemented.

Signage informing drivers that they must turn right when the crossing guard is present is a frustration for some

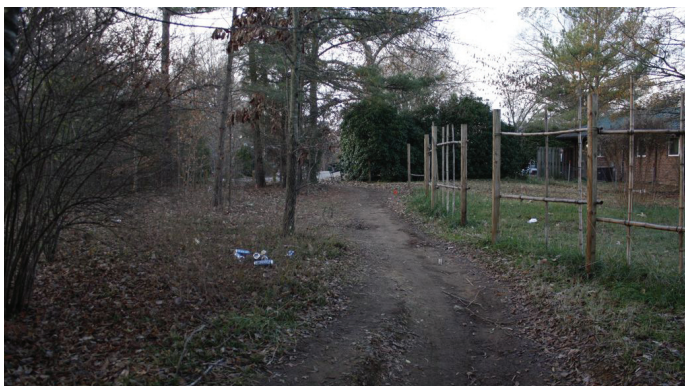
- The Estes Drive apartment complex poses a challenge as there are reportedly crime issues in and around the complex. There is valid concern for the children's safety in the afternoon walking and/or bicycling through this area. There are several trails behind the neighborhood that are utilized by children.

A path behind Estes Apartments; well traveled, but strewn with trash.

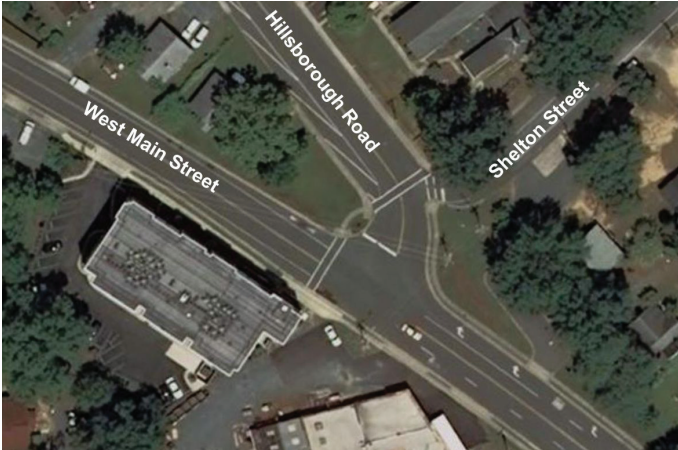
Main Street and Shelton Street is under stop control at Hillsborough Road. W. Main Street's school zone warnings include flashing yellow beacons in conjunction with school zone and pedestrian crossing signs in both directions.

The complicated intersections of Shelton and Hillsborough Streets & Hillsborough and Main Streets both pose safety hazards.

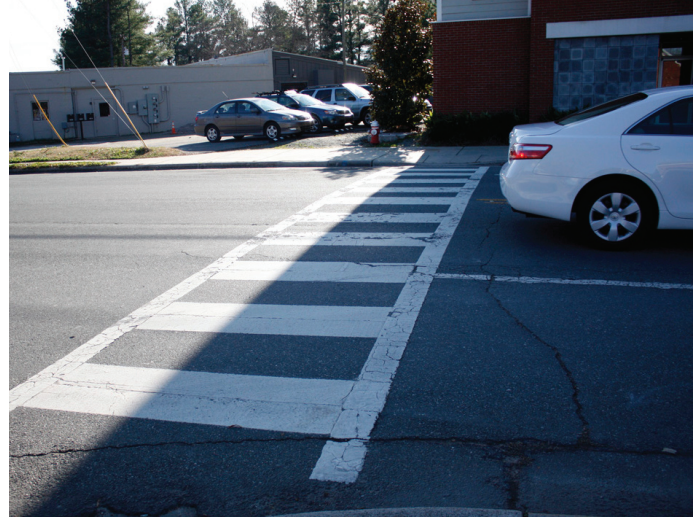
W. Main Street has one crosswalk traversing the roadway just northwest of its intersection with Hillsborough Road. There is a vertical sight distance hazard from the southeast approach of W. Main Street creating a hazard for pedestrians utilizing the crosswalk. A higher visibility crosswalk at this location would help increase driver awareness. The wheel chair ramps have the correct orientation according to ADA regulation, however, they do not have the truncated domes within the ramp.

Crosswalk across Main Street.

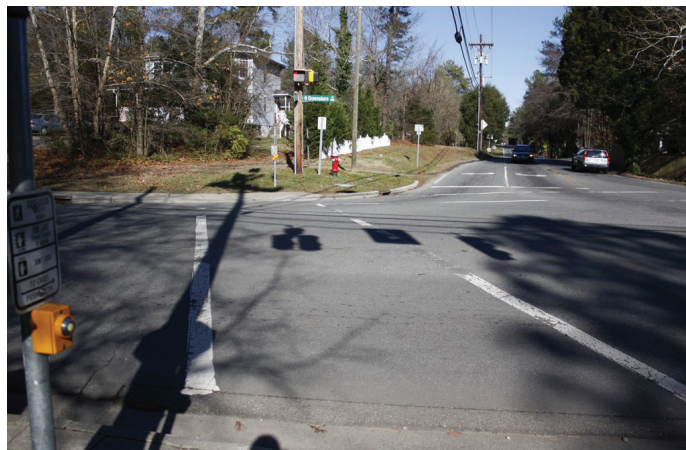
The intersection of Greensboro and Estes lacks high-visibility crosswalks.

Crosswalk markings are in need of improvement at the intersection of N Greensboro Street and Estes Drive. This intersection would benefit from the application of ladder style crosswalks to increase driver awareness.

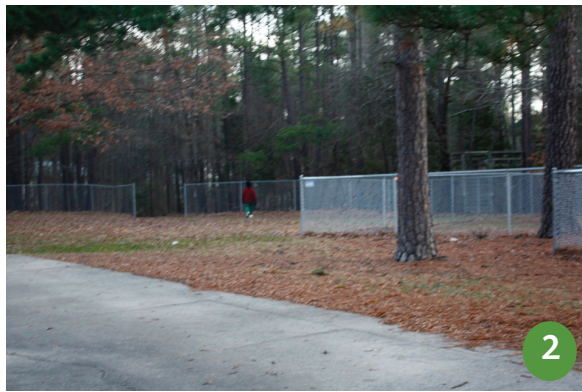
A father walks through a gap in the fence at the back of the school. This is a popular shortcut to walk to school.
